[Hughes, Stephen W.](#) (2010) A practical example of a siphon at work. *Physics Education*, 45(2), pp. 162-166.

Supplementary material on the Lake Bonney siphon

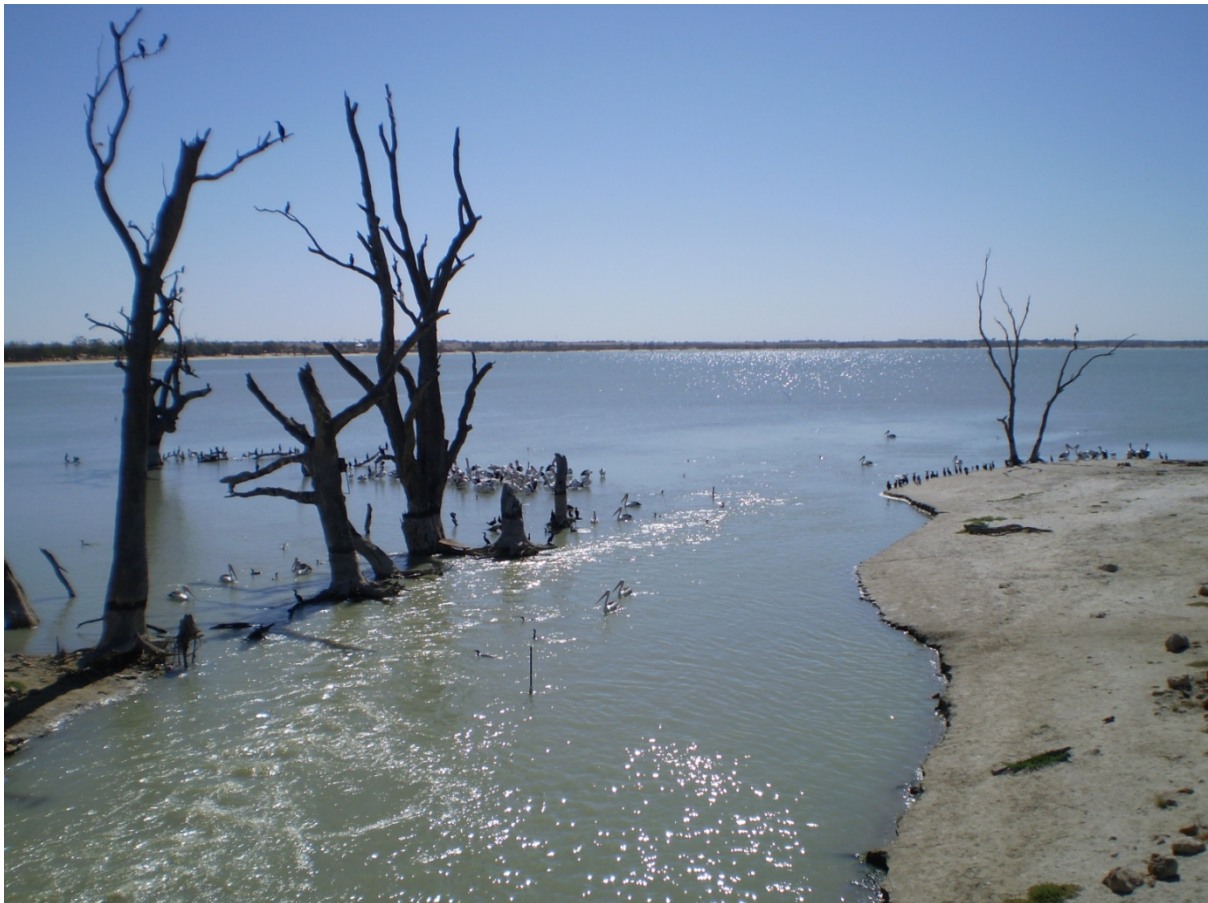
Figure 1. Water entering Lake Bonney from the siphons shown in figure 6 in the main body of the paper. Note the pelicans hoping to catch fish congregating near the outflow.

200 mm internal diameter polypipe began transferring water over the barrier built between Chambers Creek and Lake Bonney.

Since the refilling operation began, huge numbers of fish have been congregating around the pipes (seen on the video clip). In the early days of the operation of the siphon, fishermen were catching four tons of fish each day. Filling began on 1 December 2008 and finished on the 21st January 2009, 50 days in total. It is easy to see that 10 GL of water is equal to about 100 days worth of evaporation, therefore the refilling operation has delayed the drying up process by three months. After completion of the siphon operation in January 2009, the siphons were removed.
